## An Engineering Ethics Case Study Review: Petrobras P-36 Accident

O. A. A. Ghani<sup>a</sup>, M. Z. Kamruzaman<sup>b</sup>, M. F. Sulaima<sup>c</sup>, M.N. Othman<sup>d</sup>  
*Faculty of Electrical Engineering, Universiti Teknikal Malaysia Melaka, Malaysia*

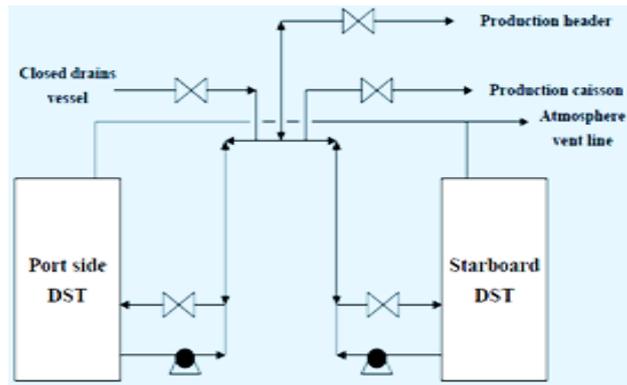
The Fig. 5 and 6 show that the system is in a multi-functional failure, as well as deficiencies in the initial setup which was introduced as a guide [4-5].Due to the delay in the drain pump port emergency drain tank inevitable and clarified the fluid flow takes approximately 1 hour. This fluid can flow through the valve leak emergency drain tank closed inner right side, which, having no secondary protection in place to prevent leakage. After the tank set off water pipes burst and the sea was breaking, flooding has caused seawater pump travel distance becomes shorter. The valve components (still in set design failure) fail in the open position, after the flood of uncontrolled inner pole began to flow freely. Despite the failure to make a choice set is not necessarily yes presumed guilty , also place control without any advance preparation system for controlling the flow of sea water when the pump is running and has are short circuited from the flood. In addition, the failure of watertight dampers in the ventilation system works add to the effects of more severe flooding.

Fig. 5 Condition of component failure

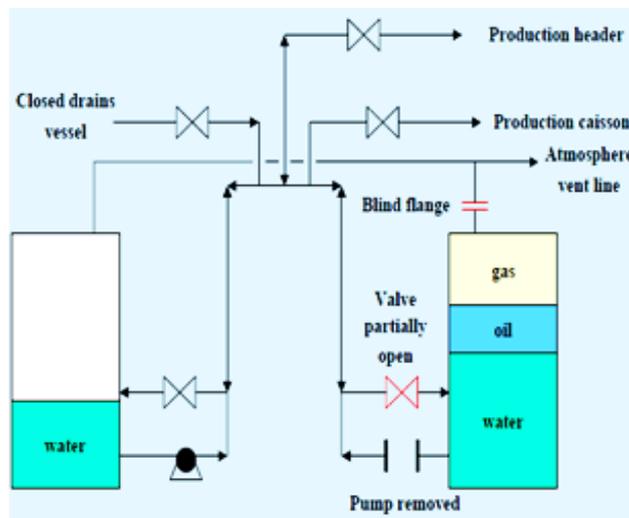
Fig. 6 Condition of valve failure
