Causes of Failure in Storage Facilities and Their Supports

¹Igbax, Sannyol Ityokumbul , ²Ogwu, Ekele Augustin, ³Atiku, Lawal Ibrahim

¹Department of Mechanical Engineering Kaduna Polytechnic

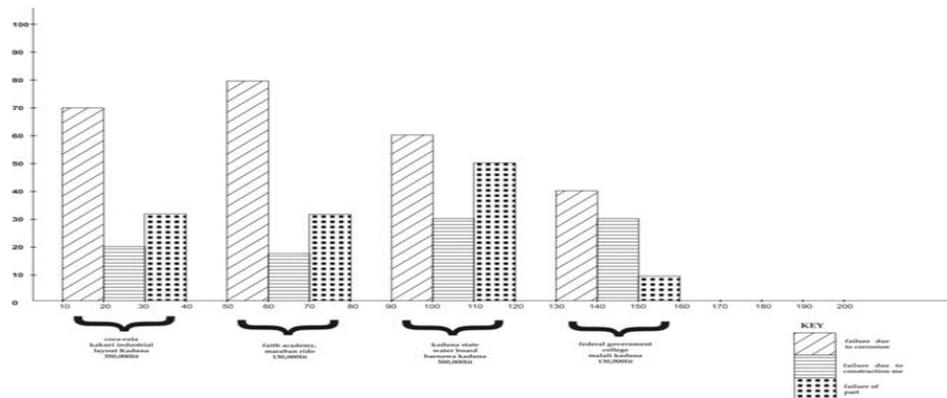
BAR CHART REPRESENTING MAJOR CAUSES OF FAILURE.

Figure 3.1 show a chart on the representation on the failures experienced and their degree of occurrence. According to data obtained in this study, the frequency of failures on a scale of 10 shows shown; Failure due to corrosion had a 50% , Failure due to construction method had 20% , Failure due to component used and other external factors had 30%.

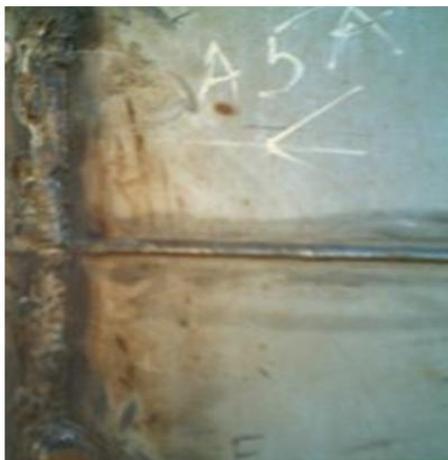
Corrosion on joint due to poor welding procedure

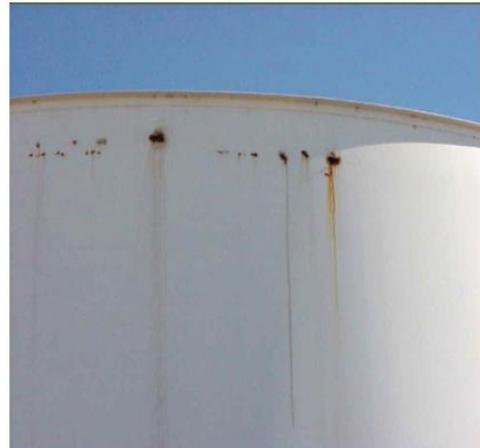
Corrosion starting due to wall failure

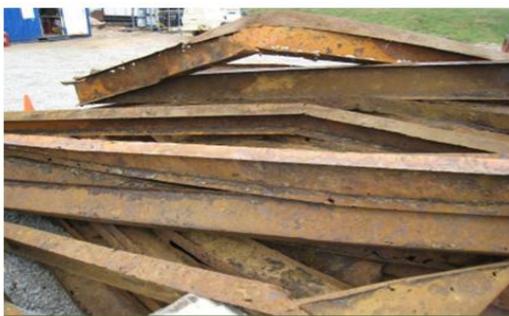
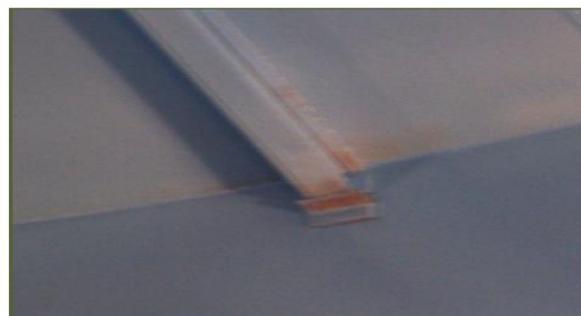
SOME PICTORIAL VIEW OF FAILED TANKS DUE TO CORROSION

Visual inspection was carried out on the tank; hence there are different types of corrosion methods e.g. pitting corrosion, general corrosion, galvanized corrosion etc [8]. which has different forms of commencement, depending on the cause. The available corroded spots were also taken into cognizance to ascertain if it is the cause of the failure in storage tank. Hence the use of mild steel plate, anti-corrosive materials like; red oxide paint, silver paint and tar coating should be engaged as they can only minimize the rate of corrosion formation.
