## Geoelectric Survey for Post-Foundation Investigation of a Distressed Building at Ade Super Hotel Akure, Southwestern Nigeria

### ABSTRACT

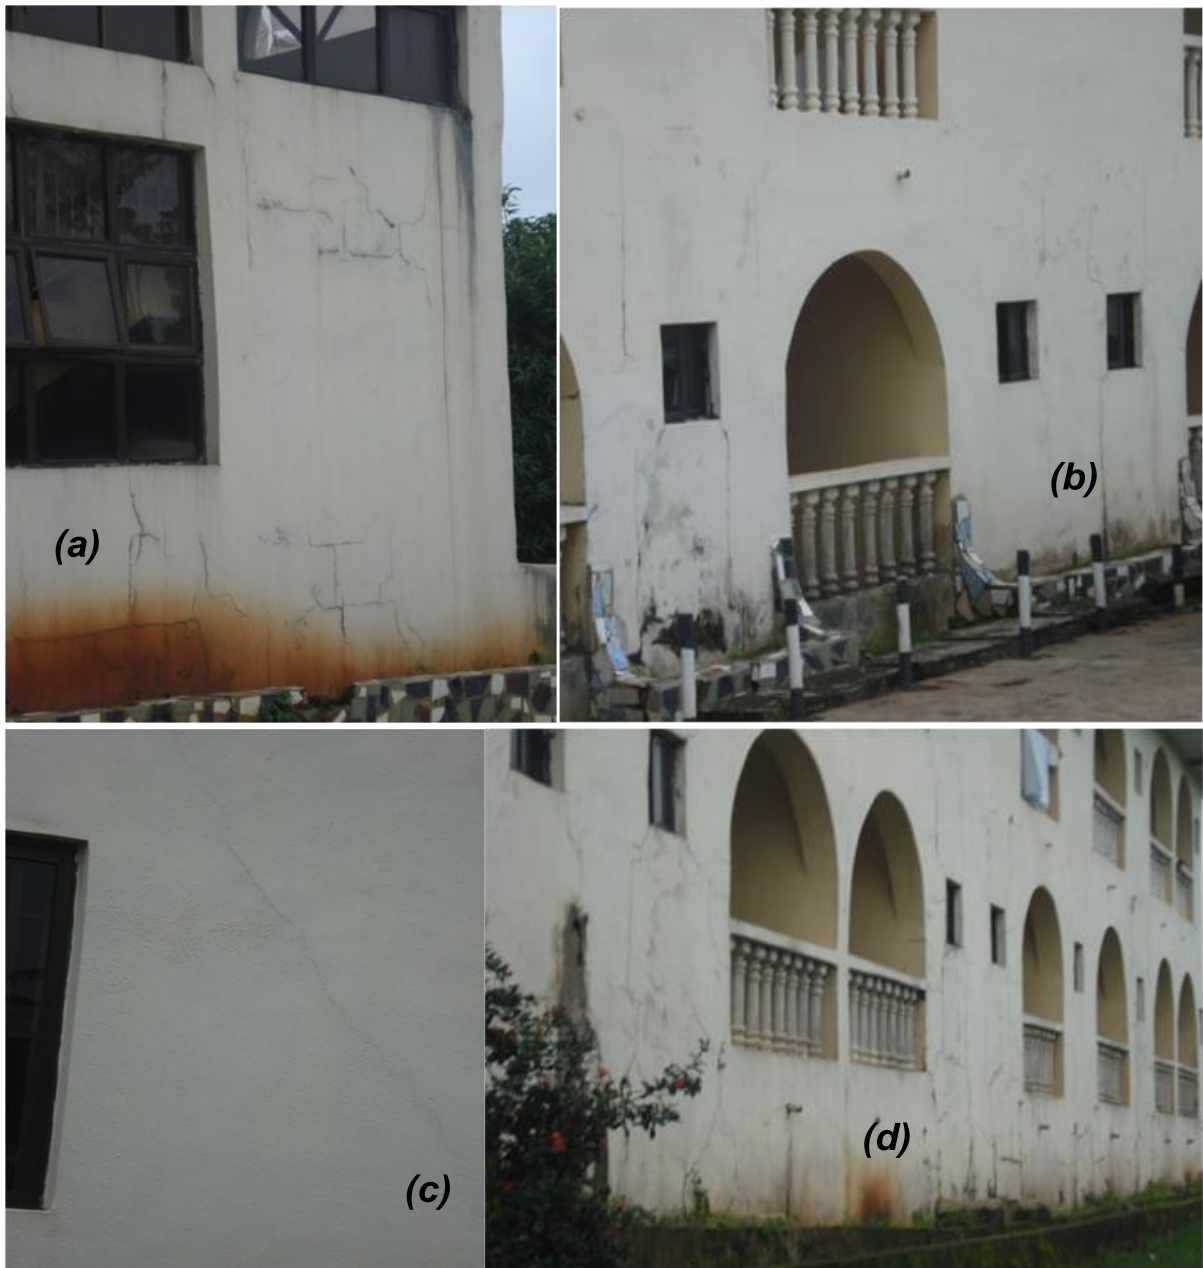
The building under study is located within the premises of Ade-Super Hotel, Akure, Ondo State, southwestern, Nigeria (Figure 1). It is located within the geographic grids (Northings) 804580 mN and 804755 mN and (Eastings) 739138 mE and 739407 mE (Zone 31, Minna datum) and accessible through Oyemekun road, Akure (Figure 1). The topographic elevation of the study area varies from 339 to 365 m above sea level and falls within the tropical rain forest climate. The study area lies within the crystalline basement complex of Southwestern, Nigeria and is underlain essentially by Charnockitic rocks (Figure 3). The building under study is a one-storey building in Ade-Super Hotel, Akure (Figures 1 and 2). The building shows cracks in various directions and dimensions (Figure 2). The neighbouring buildings around the one under study have shown little or no similar kind of distress. The basal part of the building on the four sides shows wetness and serious cracks, and some of these cracks extend to the first floor of the building.

Figure 2: Various parts of the building under study showing some of the cracks observed on it  
(a) Right, (b) Front, (c) Left and (d) Back

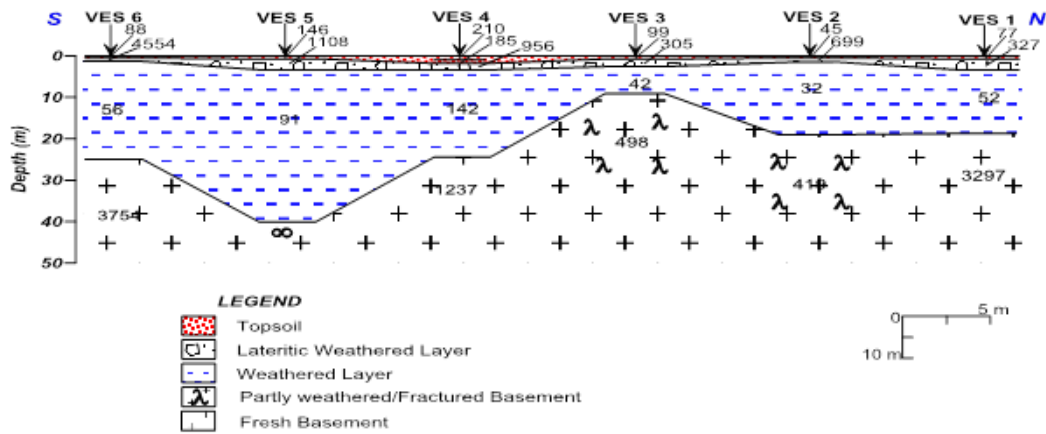
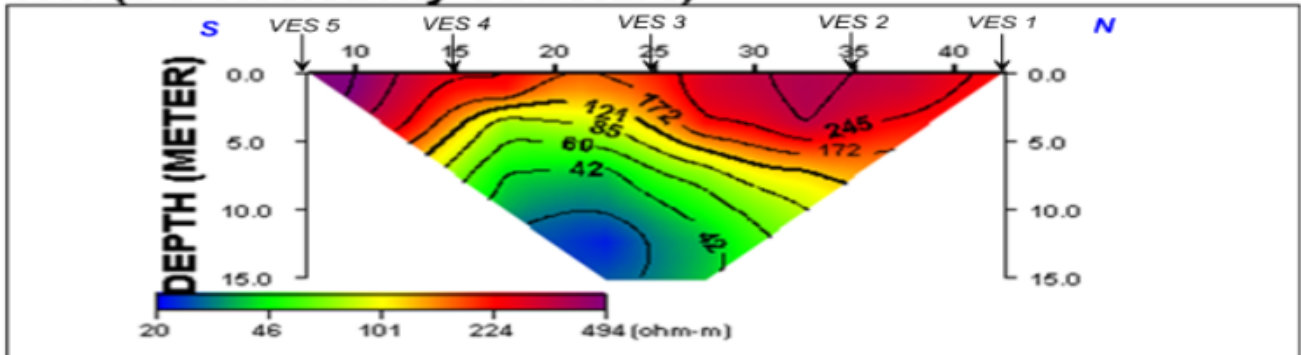
**TR1 (2-D Resistivity Structure)**

The sections revealed approximately four geoelectric layers within the study area which include; the topsoil, lateritic weathered layer, weathered layer and the partially weathered/fractured/fresh basement (Figs. 7a and 8a). The resistivity of the topsoil (clay, sandy clay, clayey sand and sand), lateritic weathered layer, weathered layer (clay, sandy clay and clayey sand) and the partly weathered/fractured/fresh basement varies from 45-210  $\Omega$ m, 305-5858  $\Omega$ m, 12-142  $\Omega$ m and 109 to 10075  $\Omega$ -m respectively, with thickness values ranging from 0.5-2.3 m, 0.2-2.8 m, 6.2-36.8 m to an undeterminable depth and depth to bedrock ranging between 9 and 40.1 m to an undeterminable depth respectively. The topsoil is generally thin (less than 1 m) within the study area except beneath VES 4 and 7 where it is thicker than 1 m. The laterite is also thin; with thickness value not more than 2 m and the resistivity shows that it is hard-pan in some areas. The weathered layer generally has great thickness and the total thickness could not be determined in some areas especially beneath VES 11 and 12 (Fig. 8a). The basement bedrock is also fractured beneath some sounding points.

The geoelectric section beneath traverse 1 (Fig. 5a) shows zones of thick topsoil/laterite and weathered layer. These areas of thick topsoil/laterite and weathered layer correlate with that observed on the 2-D dipole-dipole image, especially the reduction in the lateritic weathered layer from VES 4 to 3 which is also observed between 15-25 m on the 2-D subsurface image (Fig. 5). The 2-D resistivity structure could not image beyond 15 m (due to the 5 m electrode separation used) and the basement could not be delineated at this depth. In corroboration, it was observed that the basement could not be delineated on the geoelectric section at this depth, except beneath VES 3 and it shows an evidence of fracture. The geoelectric section beneath traverse 2 (Fig. 6a) also shows correlation on the zones of thick topsoil/lateritic weathered layer and weathered layer in both techniques. The reduction in the resistivity of the weathered layer towards the western part of the area especially between distance 15 and 35 m on the 2-D subsurface image also corroborates the low resistivity and the undeterminable depth of the weathered layer within this area especially beneath VES 11 and 12 (typical of basement structures such as fault) (Fig. 6). The similarity in the results obtained showed that the two techniques correlate and reveals the true nature of the subsurface condition in the study area. The 2-D resistivity structure beneath traverse 1 reveals a high resistivity lateritic weathered layer along the traverse to a depth of about 8 m. The layer thins to about 3 m between distance 15-25 m (between VES 3 and 4) along the traverse. The resistivity value of the lateritic weathered layer ranges from 100-494 ohm-m. The low resistivity values (20-100 ohm-m) typical of clayey materials observed beneath this layer reaches a depth of about 15 m. The presumed fresh bedrock was not delineated beneath this traverse.

Figure 5: Correlation of (a) Geoelectric Section and (b) Dipole-Dipole Pseudosection along Traverse 1

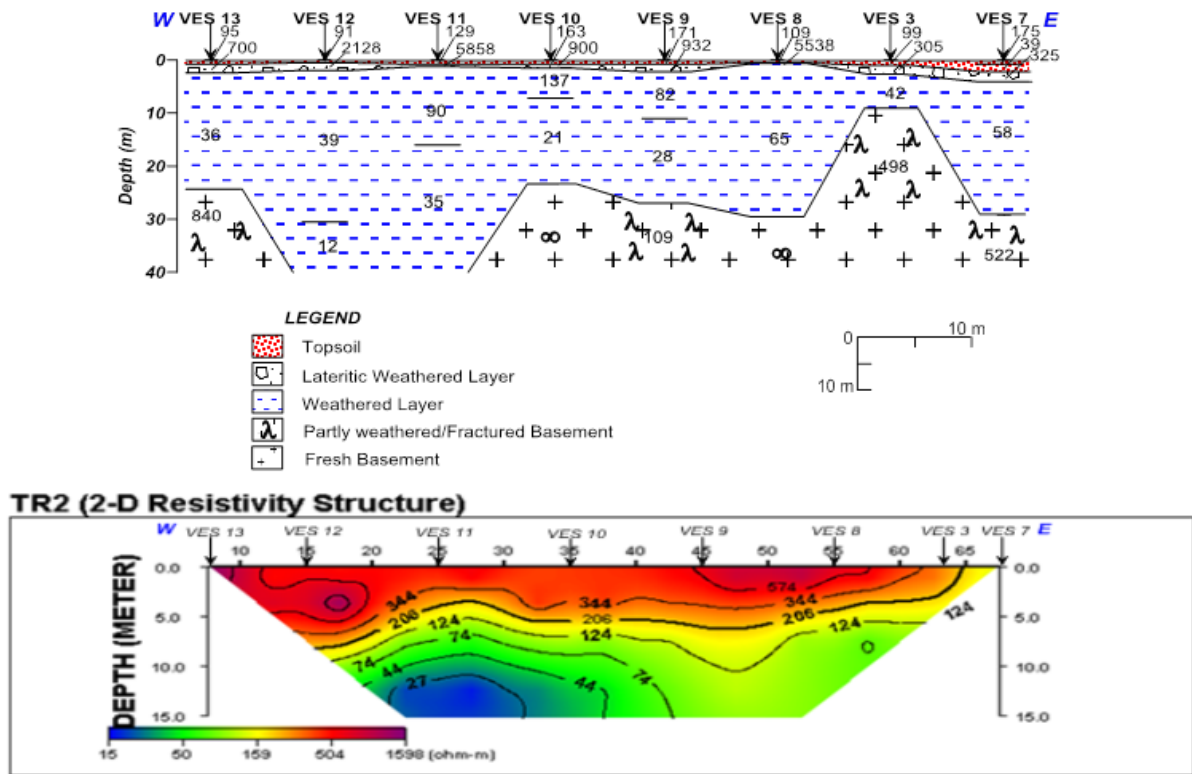
The 2-D resistivity structure beneath traverse 2 also shows a high resistivity lateritic layer along the traverse to a depth of about 5-9 m. The layer thins to about 5 m between distance 25-30 m and beyond 55 m (between VES 10 and 11 and VES 7-8) along the traverse. The resistivity value of the lateritic weathered layer ranges between 130 and 1598 ohm-m on this traverse. The low resistivity values (15-130 ohm-m) observed beneath this layer to a depth of about 15 m is typical of the weathered (clay/sandy clay) layer resistivity. The weathered layer resistivity reduces towards the western part of the area especially between distance 15 and 35 m. The basement could not be delineated beneath this traverse as well.

The geoelectric section beneath traverse 1 (Fig. 5a) shows zones of thick topsoil/laterite and weathered layer. These areas of thick topsoil/laterite and weathered layer correlate with that observed on the 2-D dipole-dipole image, especially the reduction in the lateritic weathered layer from VES 4 to 3 which is also observed between 15-25 m on the 2-D subsurface image (Figure 5). The 2-D resistivity structure could not image beyond 15 m (due to the 5 m electrode separation used) and the basement could not be delineated at this depth. In corroboration, it was observed that the basement could not be delineated on the geoelectric section at this depth, except beneath VES 3 and it shows an evidence of fracture. The geoelectric section beneath traverse 2 (Fig. 6a) also shows correlation on the zones of thick topsoil/lateritic weathered layer and weathered layer in both techniques. The reduction in the resistivity of the weathered layer towards the western part of the area especially between distance 15 and 35 m on the 2-D subsurface image also corroborates the low resistivity and the undeterminable depth of the weathered layer within this area especially beneath VES 11 and 12 (typical of basement structures such as fault) (Fig. 6).

Figure 6: Correlation of (a) Goelectric Section and (b) Dipole-Dipole Pseudosection along Traverse 2
