## Review on Strengthening of Damaged Reinforced Concrete Columns

Sidiq, Sh. M., et.al "Review on Strengthening of Damaged Reinforced Concrete Columns"  
*The International Journal of Engineering and Science (IJES)*, 9(01) (2020): 41-60.

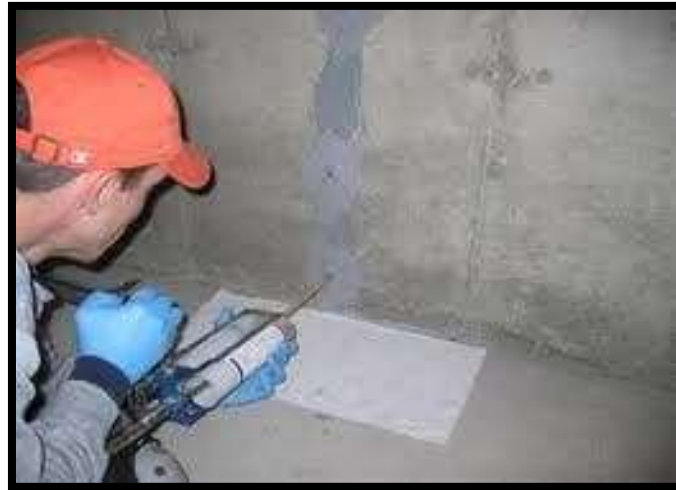
Repairing a reinforced concrete portion may be called an attempt to restore the strength and stiffness of a damaged or deteriorated reinforced concrete part to its original state. (Ju'lio et al., 2003), as shown in Figure 1.1.

**Figure 1.1:** Concrete crack repairing with epoxy injection

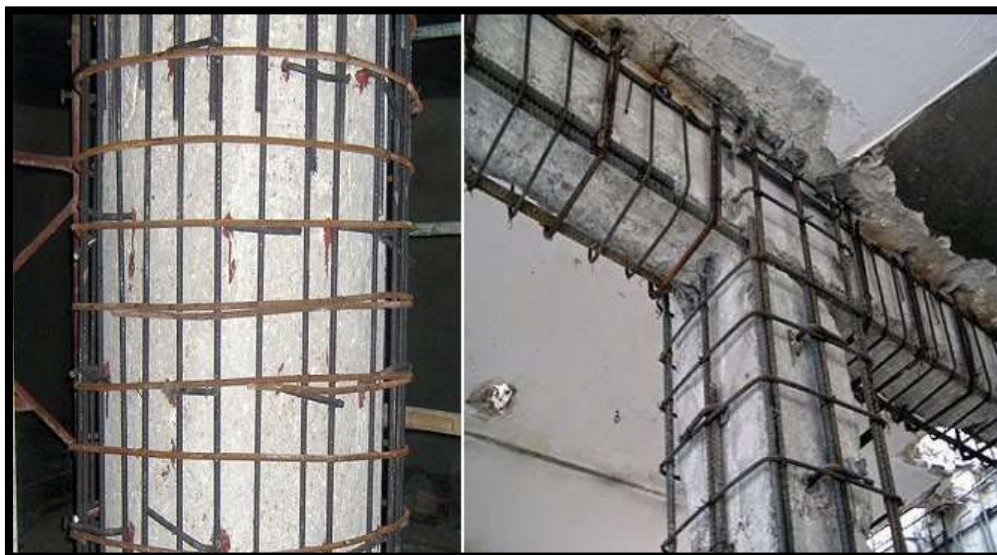
Strengthening a reinforced concrete part may be described as an attempt to increase the initial stiffness and strength of the reinforced concrete element, as shown in Figure 1.2.

**Figure 1.2:** Strengthening of concrete elements

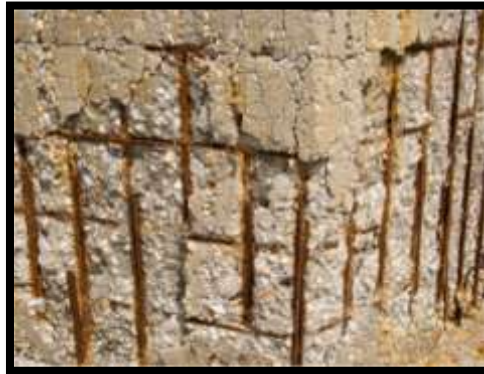
- 1- Desire to increase the column load in case of an existing error in the base design or the situation of increasing building floors.
- 2- The appearance of rust on the surface of reinforcement bars. Then, falling of concrete cover as shown within the Figure 1.3.

**Figure 1.3:** Rusty reinforcement and falling of concrete cover

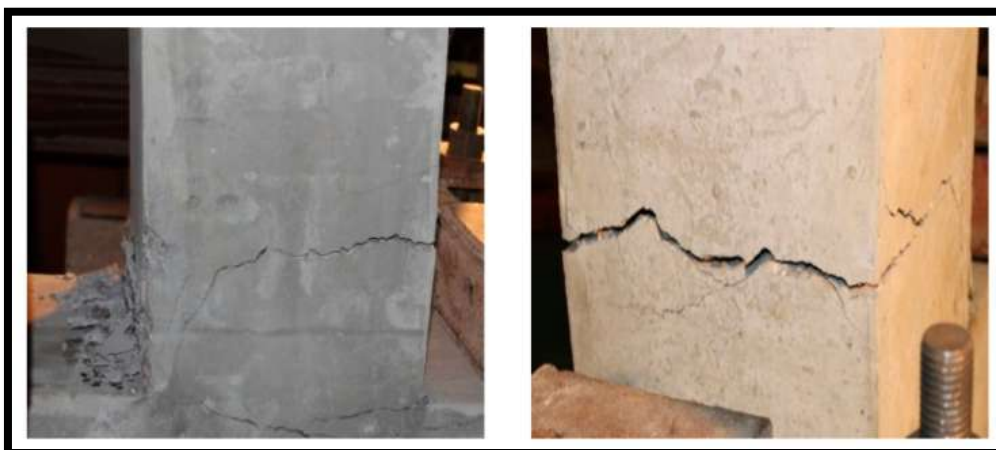
- 3- The compressive strength of the concrete column or the type and ratio of the reinforcement bars is not identical to the standard specifications.
- 4- The occurrence of cracks in the column, as shown in Figure 1.4.

**Figure 1.4:** Cracked columns

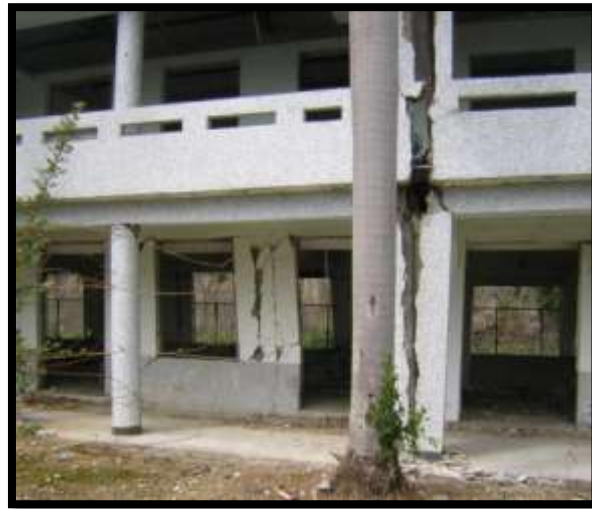
- 5- Sway<sup>1</sup> In column or settling<sup>2</sup>In foundations, as shown in Figure 1.5.

<sup>1</sup>is lateral and sideways movement of a framed structure, which makes the structure unstable geometrically.

**Figure 1.5:** Sway column

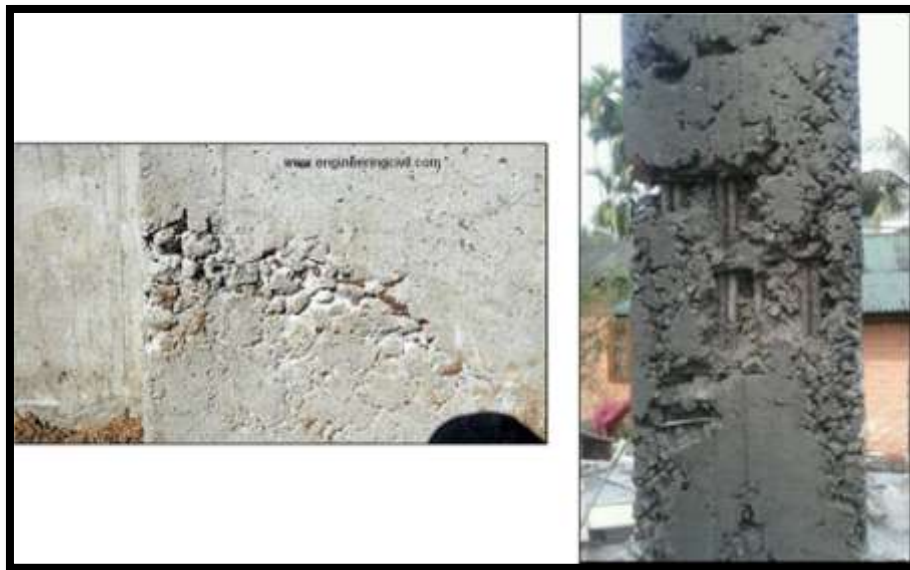
6- The occurrence of adequate nesting<sup>3</sup> Within the column's concrete as shown in Figure 1.6.

**Figure 1.6:** Nested column's concrete

<sup>3</sup> Nesting: lack of access in the concrete mix to a part of the column.

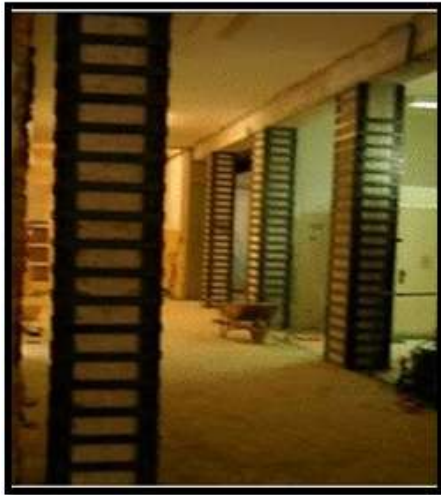
**Figure 1.7(a):** steel plate jacketing

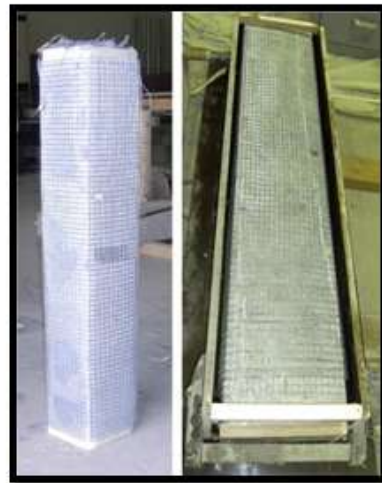
**Figure 1.7(b):** Ferro-cement jacketing

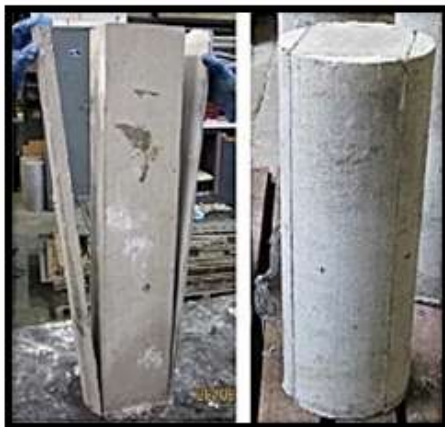
**Figure 1.7(c):** Circularization method

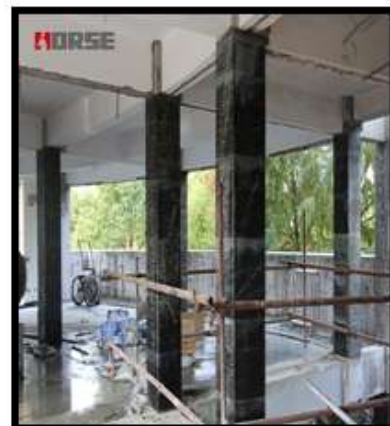
**Figure 1.7(d):** strengthening with carbon sheets

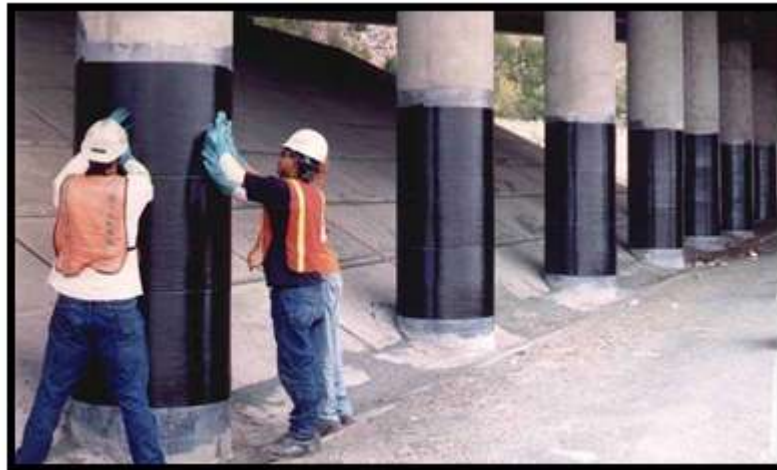
<sup>5</sup> A general term for a composite material comprising a polymer matrix reinforced with fibers in the form of fabric, mat, strands, or any other fiber form.

**Figure 1.7(e): Strengthening with FRP**

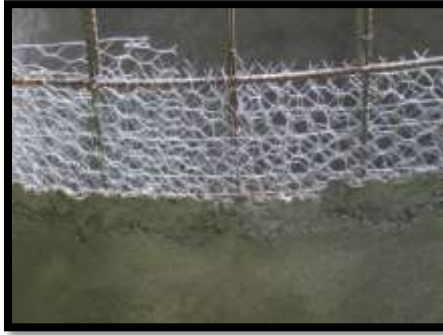
Ferro-cement is a thin wall reinforced concrete and made of cement mortar, and layers of fine wire mesh tightly bond together to create a stable and robust structural form, as shown within Figure 2.1.

Ferro-cement Confinement generally applied to compression member, to increase their load carrying capacity, enhancement of flexibility and for seismic up gradation. The unique properties of ferro-cement such as fire resistance, durability, low self-weight, waterproof and crack resistance makes it an ideal material for broader applications, and it has a great potential to be used as a jacketing material for strengthening of reinforced concrete columns (Masud & Kumar, 2016).

**Figure 2.1:** Ferrocement

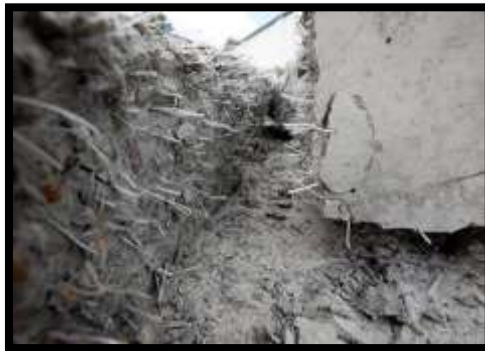
Fiber reinforced concrete is a sort of concrete that has fibrous substances that increase its structural strength and cohesion, as shown in Figure 2.2. Fiber reinforced concrete has small distinct fibers that homogeneously spread and orientated haphazardly. The fibers used are glass fibers, steel fibers, artificial and natural fibers. The characteristics of fiber reinforced concrete changed by the alteration of certain factors: type and quantity of fibers, geometric configuration, direction, dispersal, and concentration.

**Figure 2.2:** Fiber Reinforced Concrete

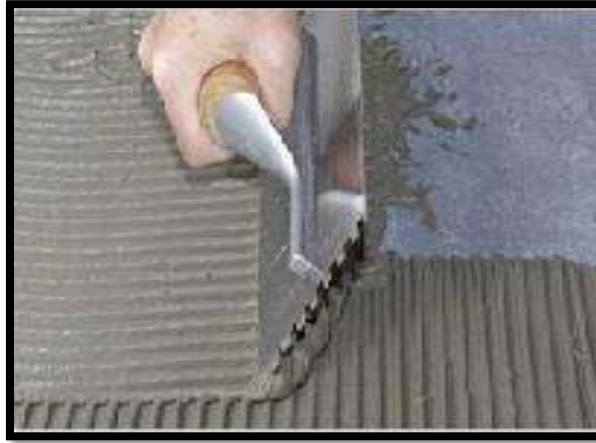
- a) **Cement grouts:** Cement grouts are mixtures of hydraulic cement, aggregate, and admixtures that when blended with the water, a trowel capable of flowing, or pump capable consistency is produced without separation (segregation) of the components as shown within Figure 2.3. Admixtures are frequently added to the grout to accelerate, or retard setting time, minimize shrinkage, improve the ability of pumping or workability, or to improve the durability of the grout. When significant amounts of grout are needed, mineral fillers can use for commercial purposes. Cement grouts can only be used for injection repairs if the opening width is adequate to accept the energetic particles suspended in the grout.

Typical applications of cement grout may vary from grout slurries for bonding old concrete with the new one to the filling of large dormant cracks or the voids around the concrete structure or under it (Zaky, 2013).

**Figure 2.3:** Cement Grout

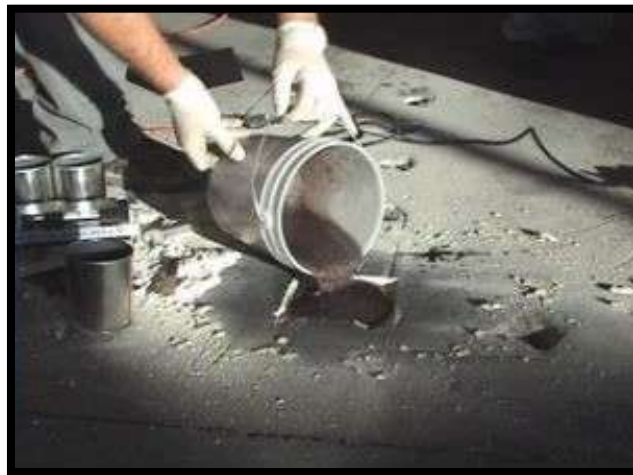
- b) Chemical grouts: Chemical grout consists of chemical solutions that react to form either a solid or a gel precipitate as compared to cement grouts comprising solid particle suspensions in a fluid, as shown within Figure 2.4. The reaction in the solution may involve only the constituents of the solution, or it may include the response of the solution with other substances, such as water, encountered in the use of the grout. The reaction causes a decrease in fluidity and a tendency to solidify and fill voids in the material into which the grout has been injected (Zaky, 2013).

**Figure 2.4:** Chemical Grout

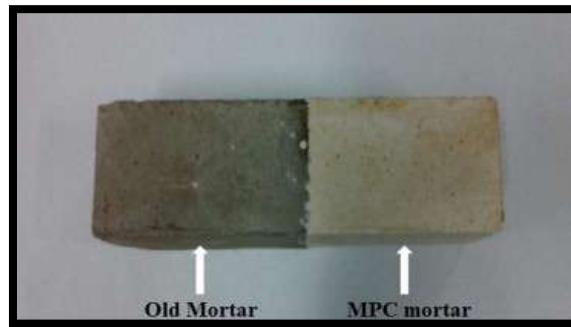
Magnesium phosphate concrete (MPC) is different from ordinary Portland cement, which based on a hydraulic cement system. MPC can achieve Rapid patch repairs economically. It has low shrinkage rates, high strength of bonds, and setting times of 10 to 20 min, which can offer 14 MPa early strength development within 2 hours, which may enhance to (45 to 60) min at room temperature for mixtures that include retarders. The abrasion resistance of MPC is comparable to ordinary concrete of similar strength when aggregates add. These can set at temperatures as low as 0 °C. The material has low permeability and excellent bond strength to Portland cement.

MPC can't be placed in a dry pack condition (water content can't adjust for this technique of placing), and hard troweling isn't possible. Any variation in the water content from that indicated by the manufacturer decreases both the durability and strength of the MPC mortar. For using it in warm conditions, hot weather formulas are present. Special care must be taken when putting the material in isolated cavities due to rapid exothermic reaction or in thickness greater than 100 mm. ("Magnesium Phosphate Concrete,") MPC has shown in Figure 2.5.

**Figure 2.5:** Ordinary and MPC mortar

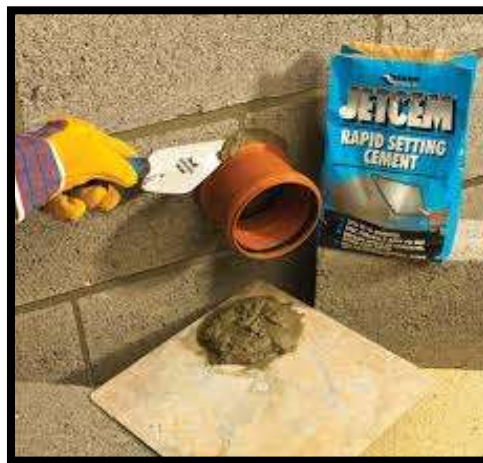
**Figure 2.6:** Rapid setting cement

Rapid Setting Concrete has to mix with 2.5 – 3.3 liters of clean drinking water to produce a workable concrete mixture. Slight water modifications may be required to achieve the desired consistency. Excessive addition of water will significantly weaken the blend. Rapid Setting Concrete is the only sufficient material which can install in 10 minutes.

There are many advantages of rapid setting concrete over ready mixed mortar such as Rapid Setting, Rapid strength development, Weatherproof, Eliminates wastage, and easy to use. ("Rapid Setting Concrete,") as shown in Figure 2.6.

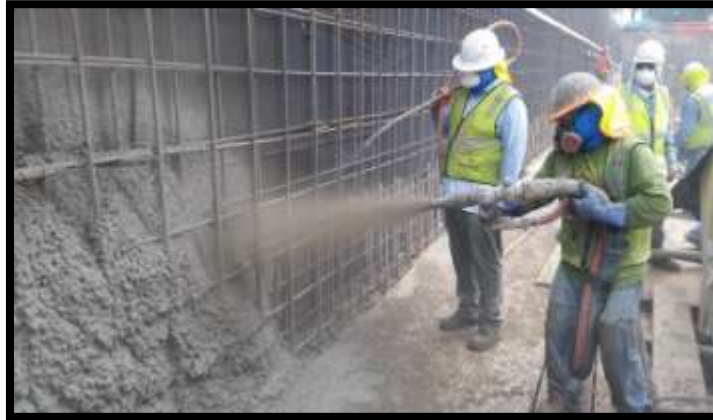
Shotcrete is a standard concrete, which is sprayed through a nozzle under pressure, as shown in Figure 2.7, on a prepared concrete surface with low water content. This pressure force compacts the shotcrete, producing a dense homogenous mass, used for replacement of damaged or deteriorated concrete as well as for jackets.

The provided shotcrete reinforcement usually weld wire fabric and deformed bars that tack into the current concrete surface, which improves the bond between existing and new concrete. The application by shotcrete requires no formwork and apply to any concrete surfaces, including inclined and vertical surface and also roof slabs. The results are excellent with proper compaction due to an application under pressure and excellent adhesion between new and old concrete.

**Figure 2.7:** Shotcrete

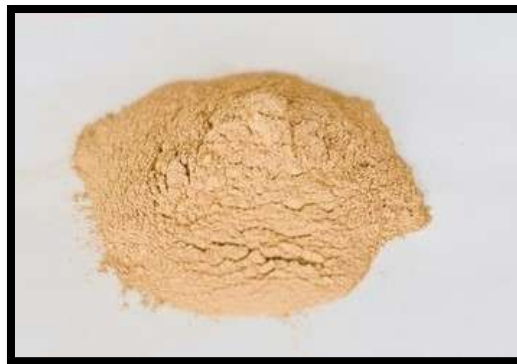
Shrinkage-compensating concrete produce from expansive cement, which expands during the first week of curing, through the formation of ettringite crystals, as shown within Figure 2.8. The concrete returns to its initial size, when the moist cure completed, standard concrete is not doing this. The concrete starts to shrink after pouring due to the volume loss due to water evaporation and contracts to a smaller size. If the floor didn't adequately design and constructed, this causes the joints to crack, curl ultimately and spall. Shrinkage-compensating concrete will resist and minimize cracking and curling. Its size increases throughout the expansion restrained by internal reinforcement. Compressive stress is put on the concrete internally, which is then relieved by subsequent minimal shrinkage. The expansive property regulates the contraction in such a way as to eliminate or reduce that seen in normal cement ("Exactly What is Shrinkage-Compensating Concrete,").

**Figure 2.8:** Expansive cement admixture

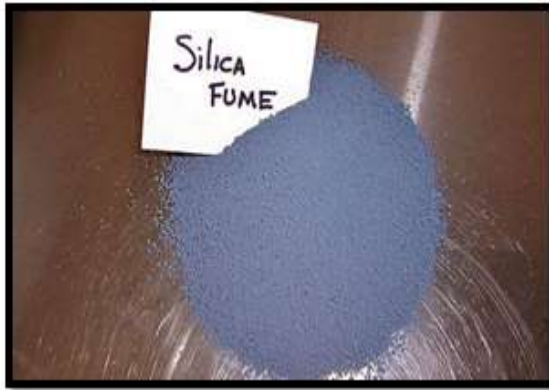
Figure 2.9: Silica Fume

Silica Fume (as shown in figure 2.9) is now used widely for high strength structures, the silica fume density ranges between 150 and 700 kg/m<sup>3</sup>, and it is ideal as a concrete additive when its density is around 550 kg/m<sup>3</sup>. It contains more than 90% silicon dioxide, and other constituents are sulfur, carbon, and oxides of iron, aluminum, magnesium, sodium, calcium, and potassium.

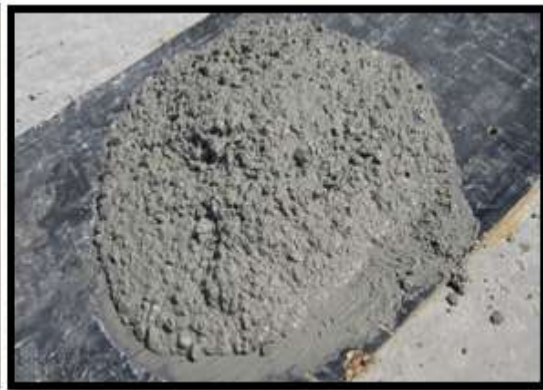
Figure 2.10: Fresh Silica Fume Concrete

It has several advantages of various types of concrete, and it improves the characteristics of hardened and fresh concrete, Fresh concrete produced from silica fume is more cohesive, reduces bleeding and segregation, improves the concrete durability, Lack of bleeding makes a more efficient finishing process. Loose and fresh silica fume showed in Figure 2.10.

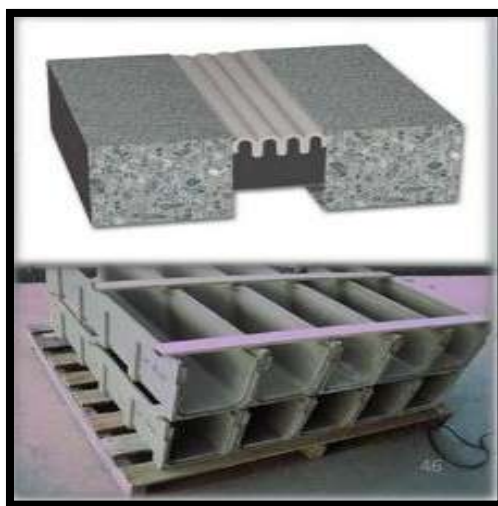
Polymer concrete is a composite material in which the aggregate in a matrix with a polymer binder is bound together, as shown within Figure 2.12. There is no hydrated cement phase in the composites, although Portland cement may use as an aggregate or filler. The formulation of polymer concrete composites relies on a unique mixture of characteristics. These include rapid curing at ambient temperatures ranges between  $-18$  to  $+40^{\circ}\text{C}$  ( $0$  to  $104^{\circ}\text{F}$ ), high flexural, tensile, and compressive strengths, excellent long-term durability with respect to freezing and thawing cycles, excellent adhesion to the most surfaces, low permeability to water and aggressive solutions, lightweight and excellent chemical resistance ("Polymer Concrete,").

**Figure 2.12:** Polymer Concrete

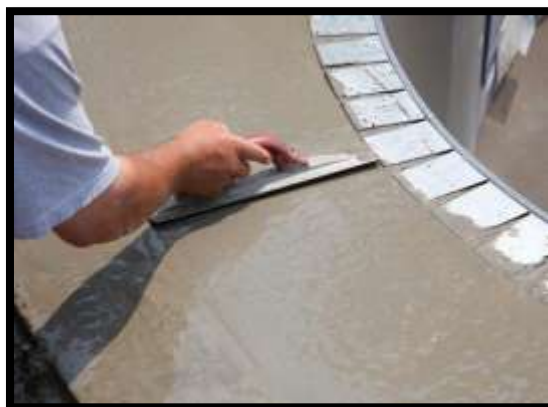
Polymer cement concrete (PCC) is a concrete composite of polymer in which both cement paste and polymer served as binders. PCCs most commonly made by adding a polymer emulsion (i. e. latex) to the fresh concrete mixture. The performance of (PCC) is investigated with a particular focus on concrete block paving characteristics, both mechanical properties such as abrasion resistance, impact resistance, and tensile/flexural strength and durability related characteristics such as freezing/thawing resistance, capillary suction, and chemical resistance. Specific examples given for each of the properties and the relevance of concrete block paving discuss. The importance of choosing the right principle to compare PCC with normal concrete and the correct type of polymer are stressed.

**Figure 2.13:** Polymer Cement Concrete

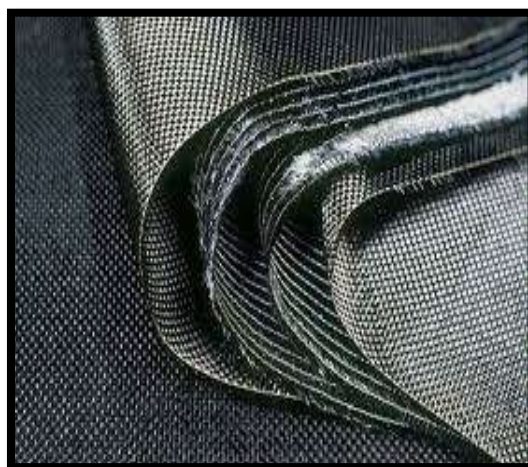
FRP is suitable for strengthening RC columns due to their excellent resistance to corrosion, high strength and stiffness-to-weight ratio, lightweight, excellent mechanical properties, quickly and easily applied, and minimal effect on columns geometry. Over the last two decades, many studies have been conducted to investigate the behavior of RC columns strengthened by CFRP sheets. It concludes that the level of strengthening of RC columns using CFRP depends on many factors: concrete strength, the columns' cross-section and slenderness ratio, the number of CFRP layers, fiber orientation, type of matrix, and the bond at the interface between concrete and the composite sheet. FRP shows in Figure 2.14.

**Figure 2.14:** Fiber Reinforced Polymer
