Soil-Cement Stabilization Using Papalanto to Sagamu Road in Ogun State, Nigeria as Case Study

Yemi Kehinde Ariye, Kaile Abdulmalik A, and Akeem Olarenwaju Adigun

Yemi Kehinde Ariye, et. al. "Soil-Cement Stabilization Using Papalanto to Sagamu Road in Ogun State, Nigeria as Case Study." *The International Journal of Engineering and Science (IJES)*, 9(6), (2020): pp. 27-35.

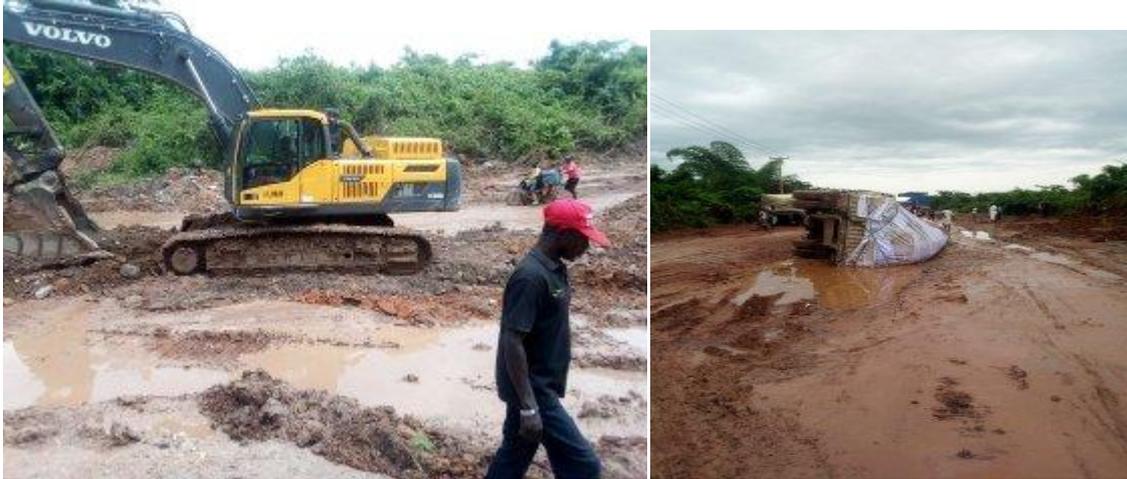
CHAINAGE: 7+241 – 7+818

Pictorials of Existing Condition
